Training workshop "Studying international practices in implementation of innovative energy efficiency technologies in the electric power industry. Methodology, goal and objectives of electricity and heat consumers energy survey" SEIT building, 62 Bayram Khan st, Mary, 13-19 March 2024 The most common mistakes in the construction of passive buildings

and technical measures in construction supervision to ensure energy efficiency

> Agris Kamenders, International Consultant, SECCA

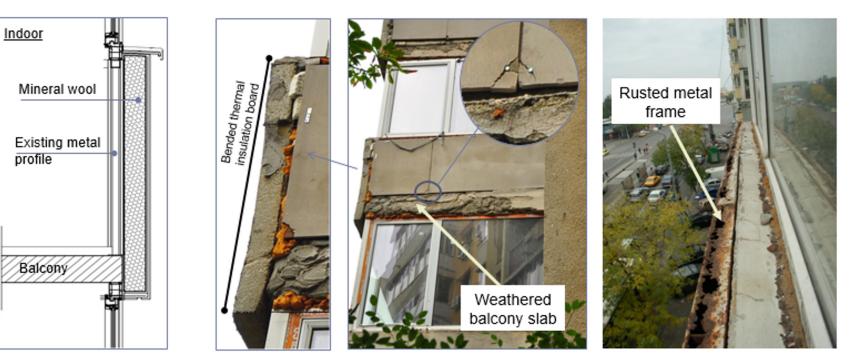
Closing of loggias

Implementation?

- Evaluate existing parapets carefully before insulating loggias.
- Consider removing old parapets and installing sandwich panels or constructing new lightweight parapets conducive to insulation.

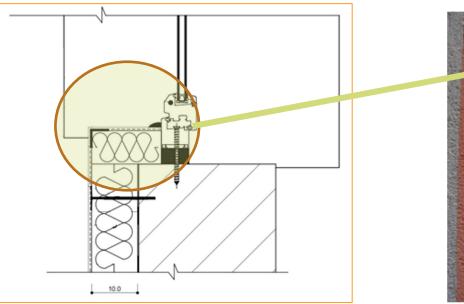
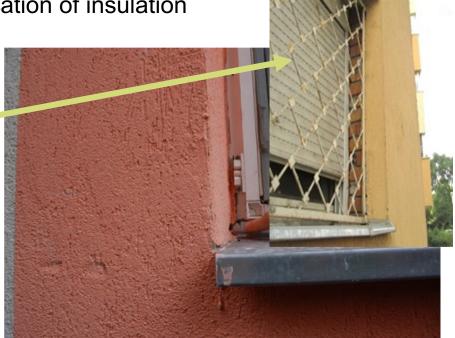
Thermal insulation of windows sills and jambs

Difficult for windows already replaced by tenants Installed windows did not take into account the application of insulation

• Include additional instructions for thermal insulation of windowsills and jambs in confined spaces.

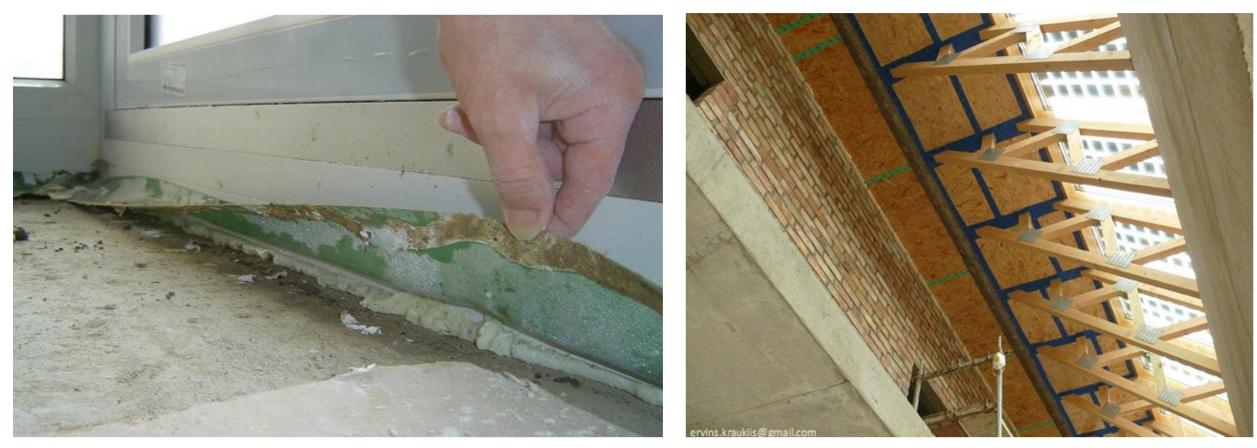
Window connections - lack of tightness, dirty surface

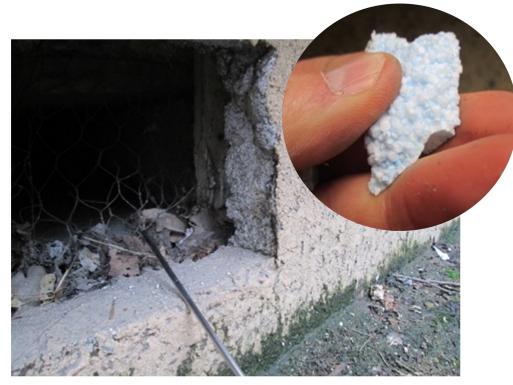
Use of wrong material

<u>Project design</u>: XPS for thermal insulation of building plinth <u>Implementation</u>: with EPS

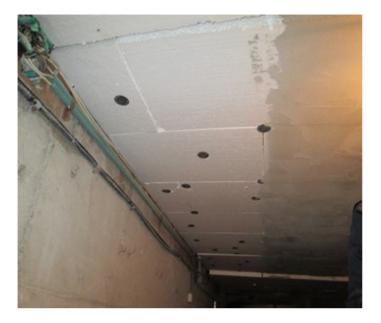
- <u>Project design</u>: Mineral wool for thermal insulation of basement ceiling
- Implementation: with EPS

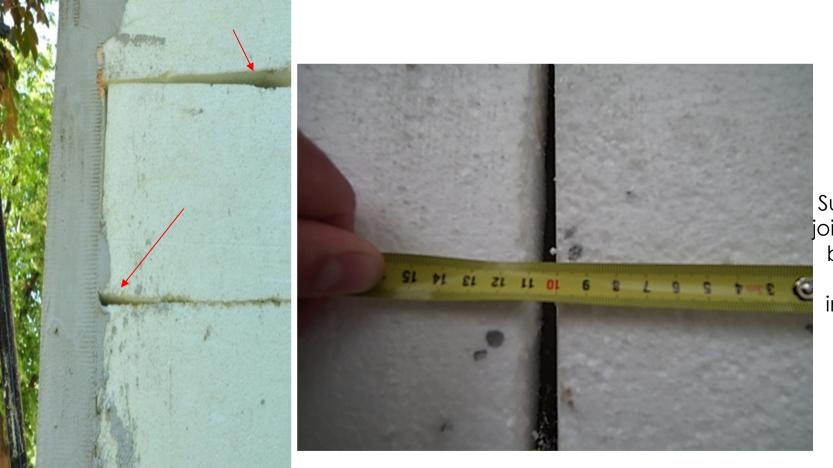
Wrong application of thermal insulation boards

Substantial joint (>1cm) between thermal insulation panels

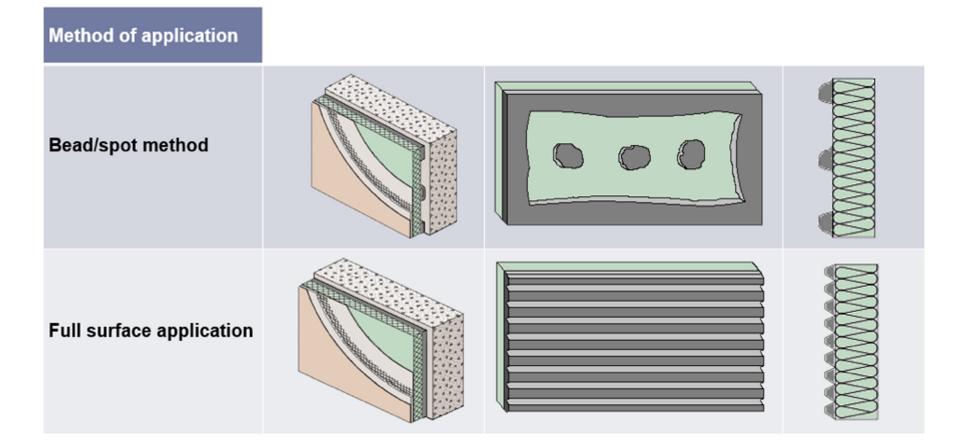
Adhesive mortar for installation of insulation boards

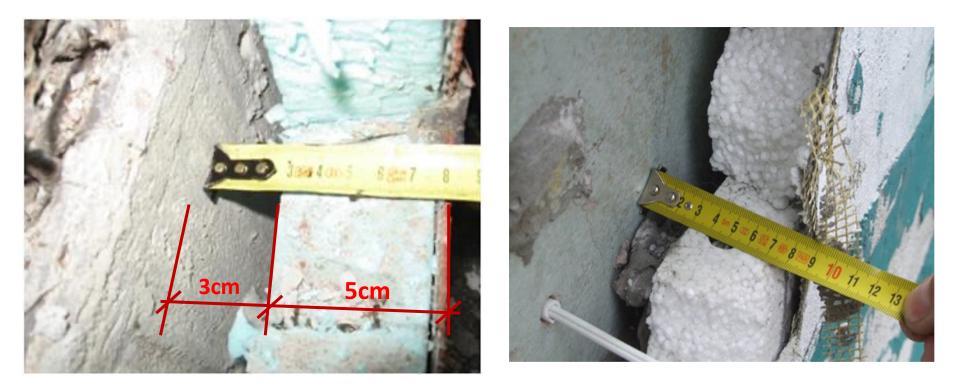
Wrong application of thermal insulation boards

Insulation board not in contact with the substrate and attached with spot adhesive only without bead

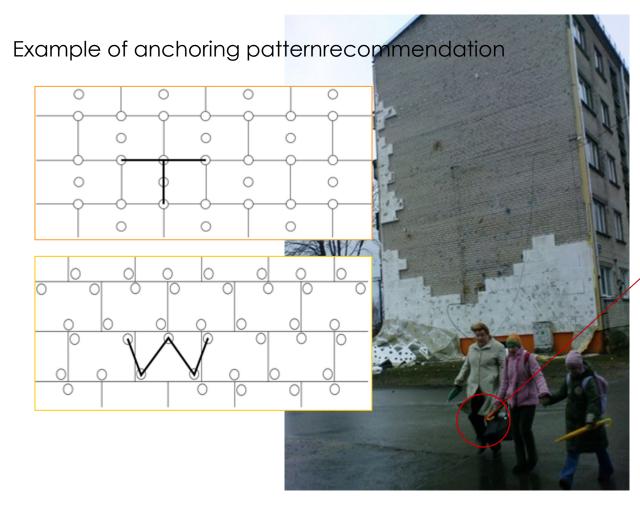
Anchoring the thermal insulation boards

- Wrong application of the adehesive mortar (lack of bead layer, only few spots applied)
- 2. Anchors were not installed

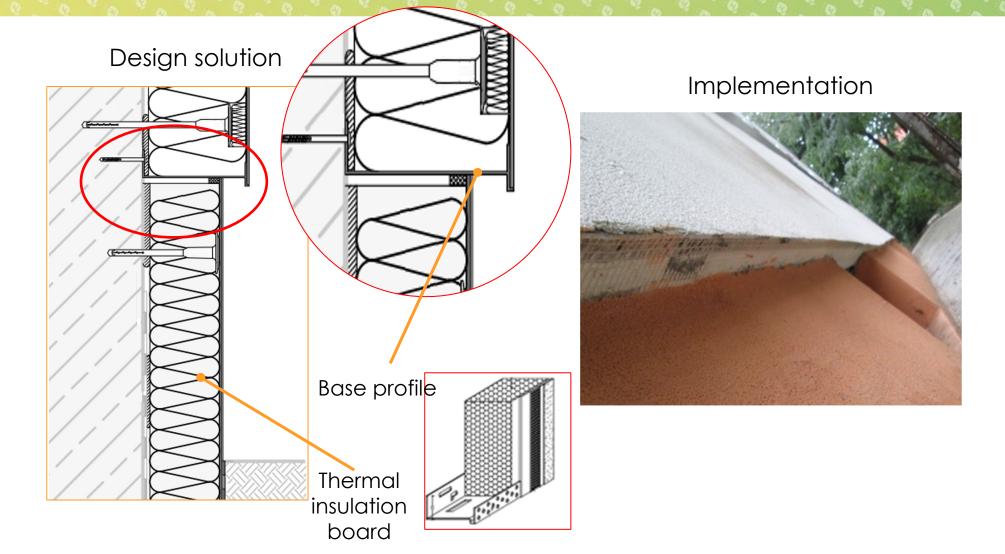
Missing steel profiles

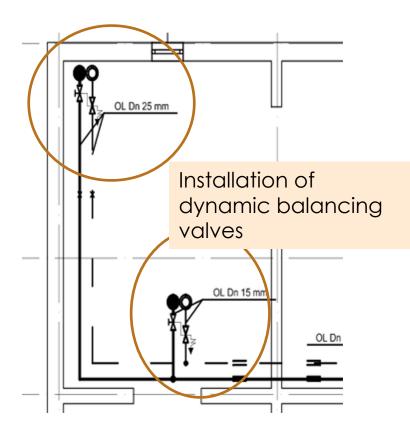
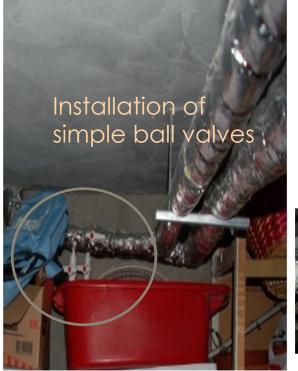
Heating and domestic hot water

Poor quality of technical insulation

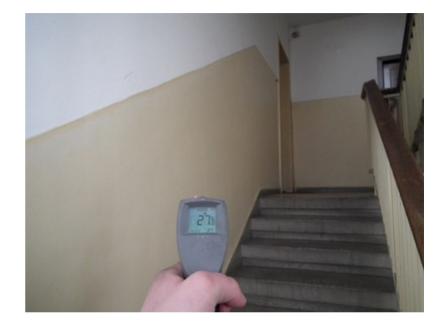
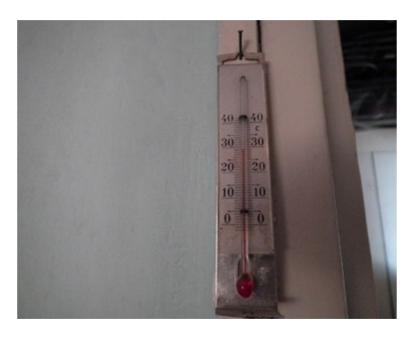
After renovation remember to tune your heating system, otherwise 27°C in the staircases and 30°C in apartments can be expected
