Training workshop “Studying international practices in implementation of innovative energy efficiency technologies in the electric power industry. Methodology, goal and objectives of electricity and heat consumers energy survey”

The most common mistakes in the construction of passive buildings and technical measures in construction supervision to ensure energy efficiency

Agris Kamenders,
International Consultant, SECCA

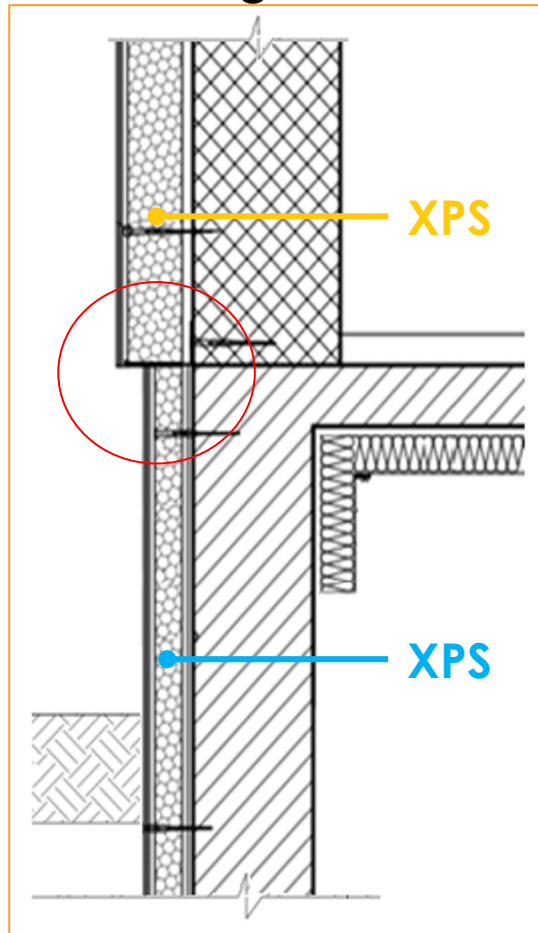
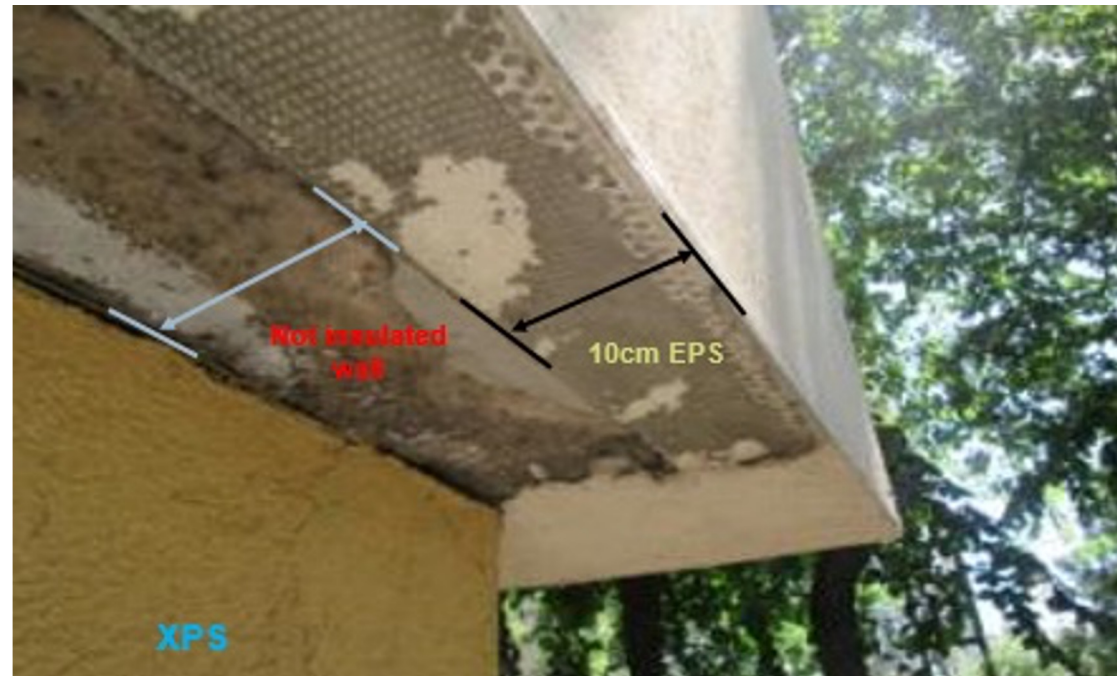
Offset of plinth walls

Not insulated
area
Thermal
bridge

- Ensure proposed insulation solutions are free of thermal bridges.
- Apply suitable waterproofing measures to prevent moisture infiltration.

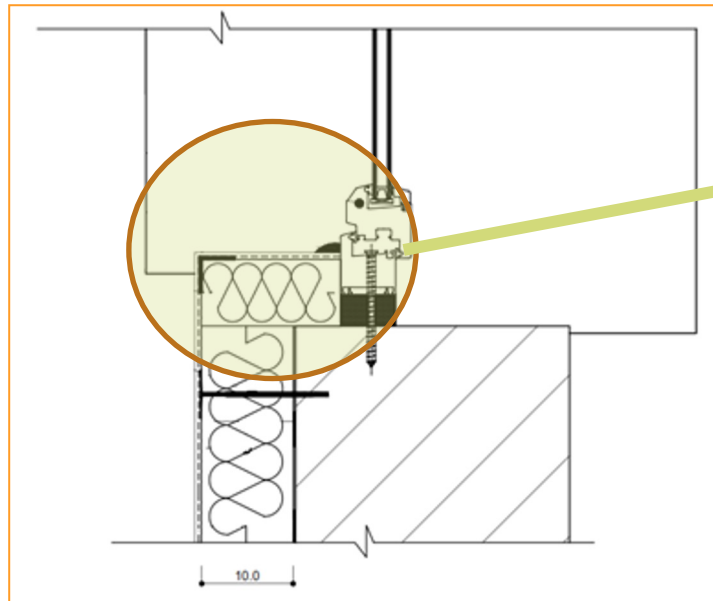
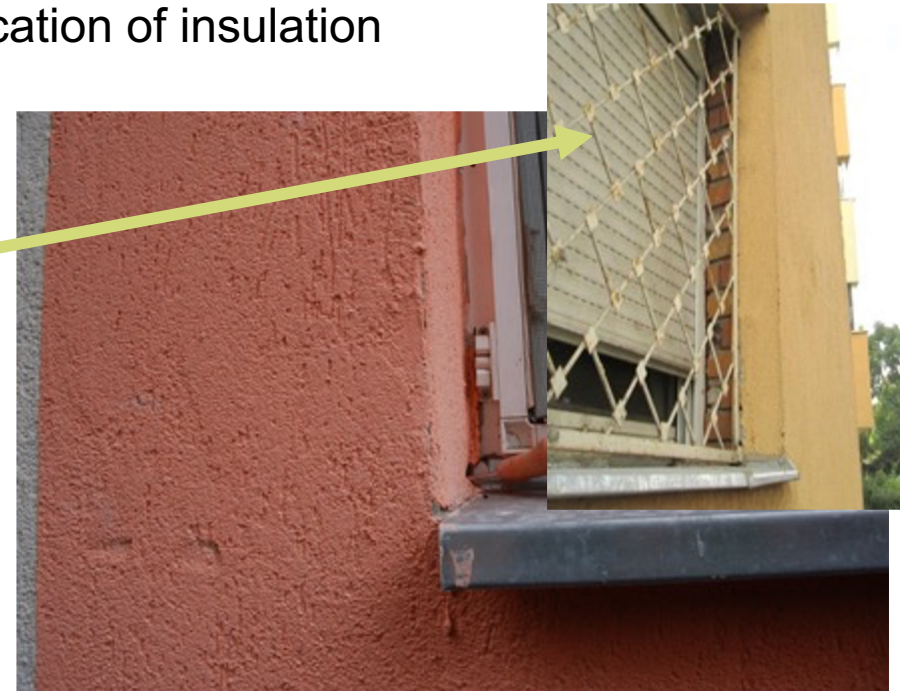
Thermal insulation of windows sills and jambs

Difficult for windows already replaced by tenants

Installed windows did not take into account the application of insulation

- Include additional instructions for thermal insulation of windowsills and jambs in confined spaces.

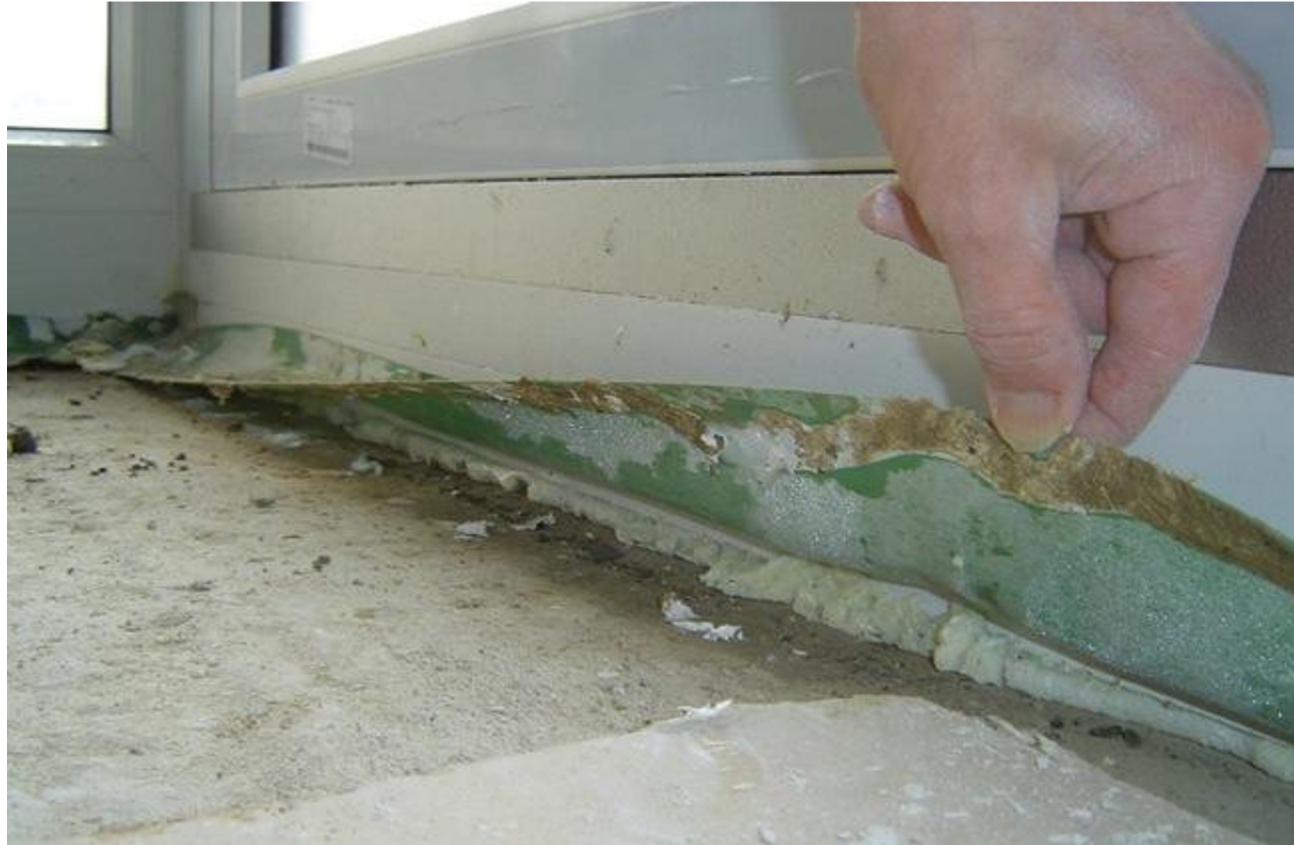
Window connections - lack of tightness, dirty surface

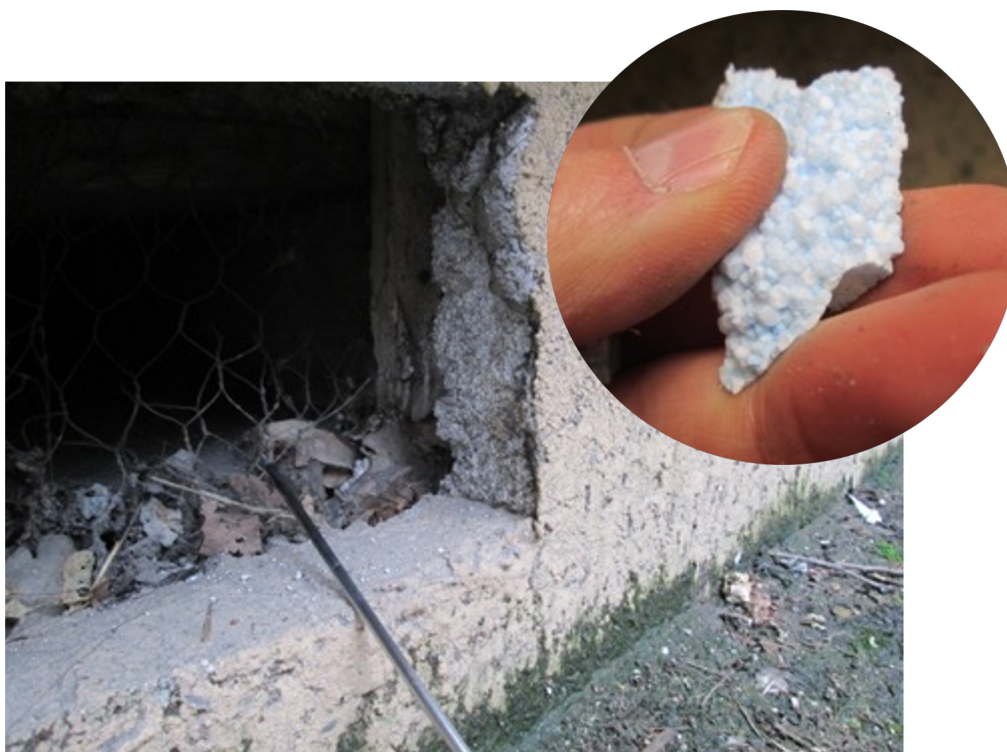
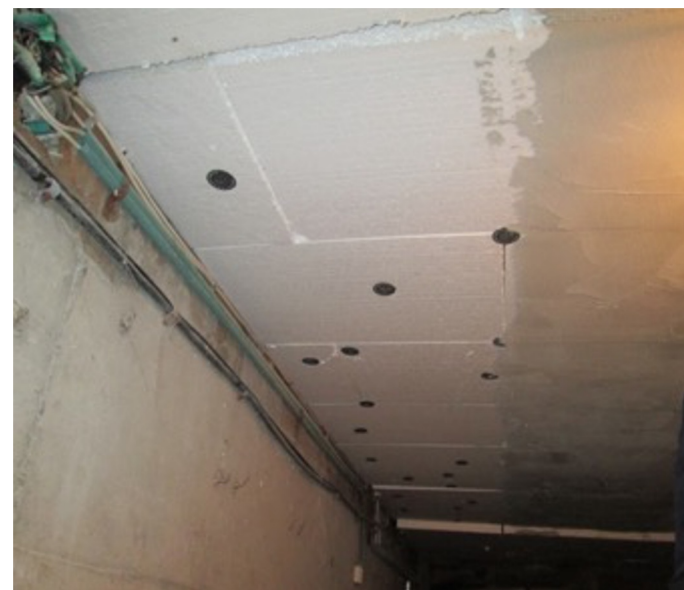
Use of wrong material

Project design: XPS for thermal insulation of building plinth

Implementation: with EPS

- Project design: Mineral wool for thermal insulation of basement ceiling
- Implementation: with EPS

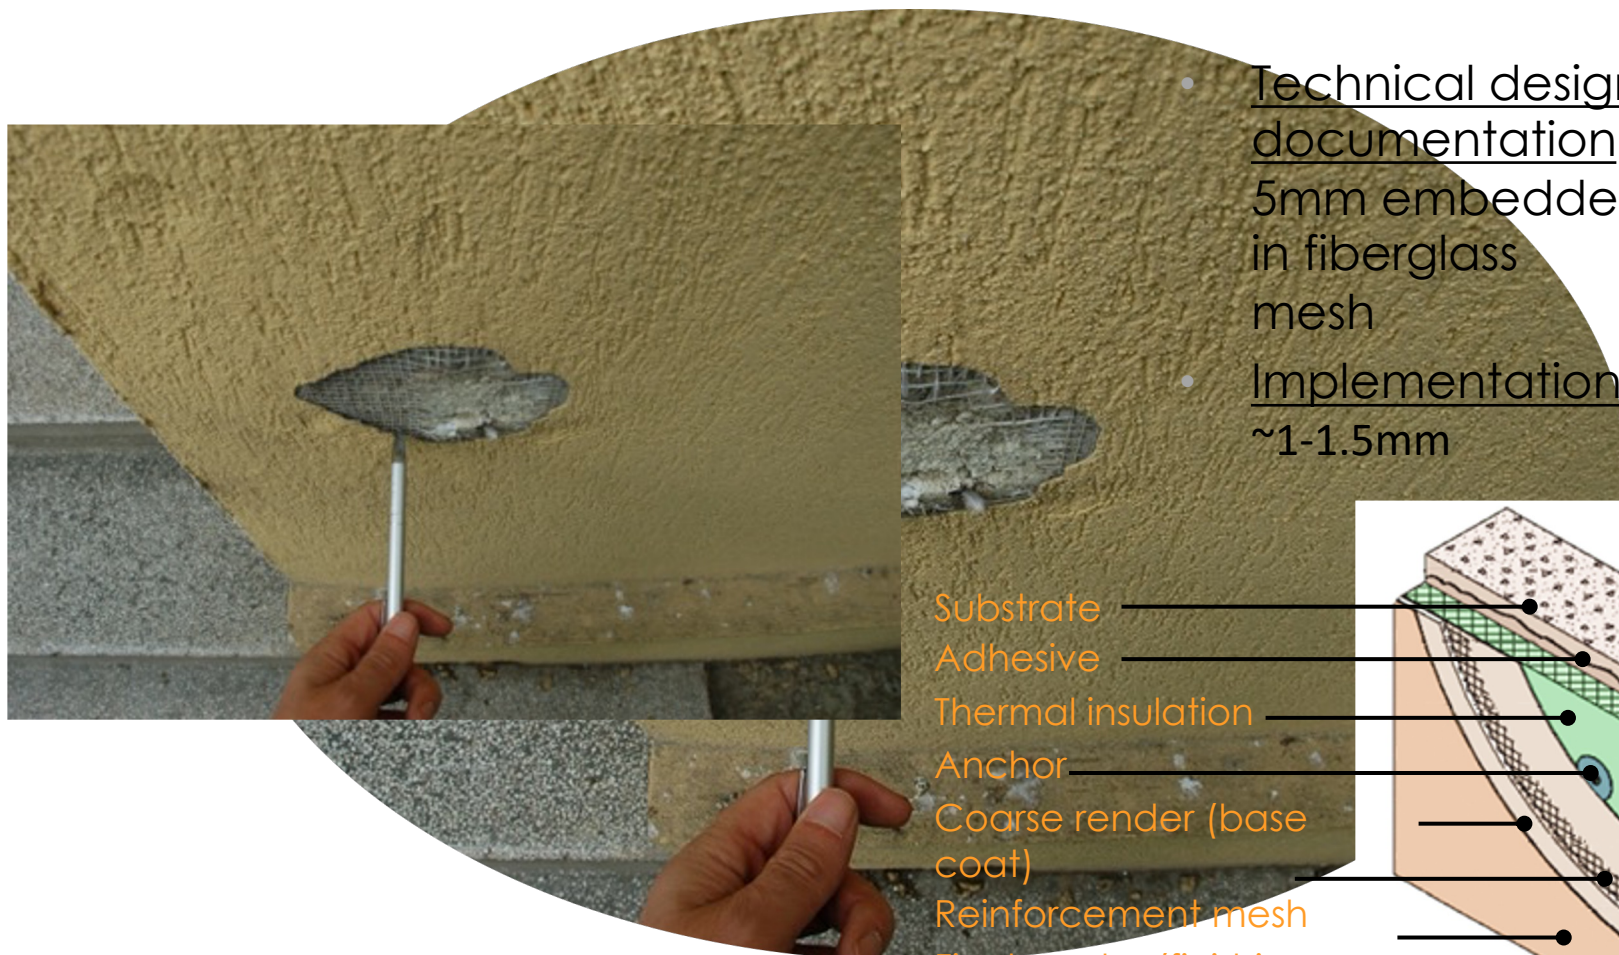
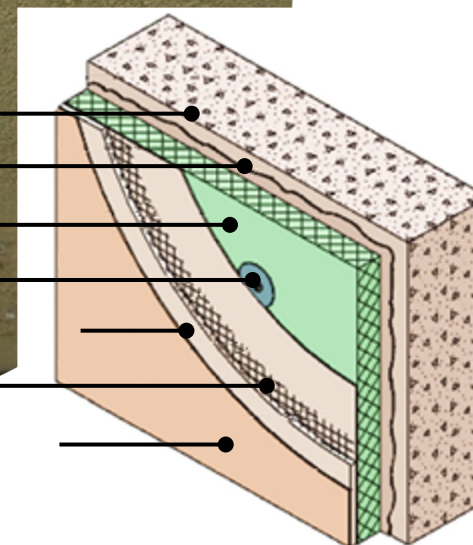
Thickness of specialist render

- Technical design documentation:
5mm embedded in fiberglass mesh
- Implementation:
~1-1.5mm

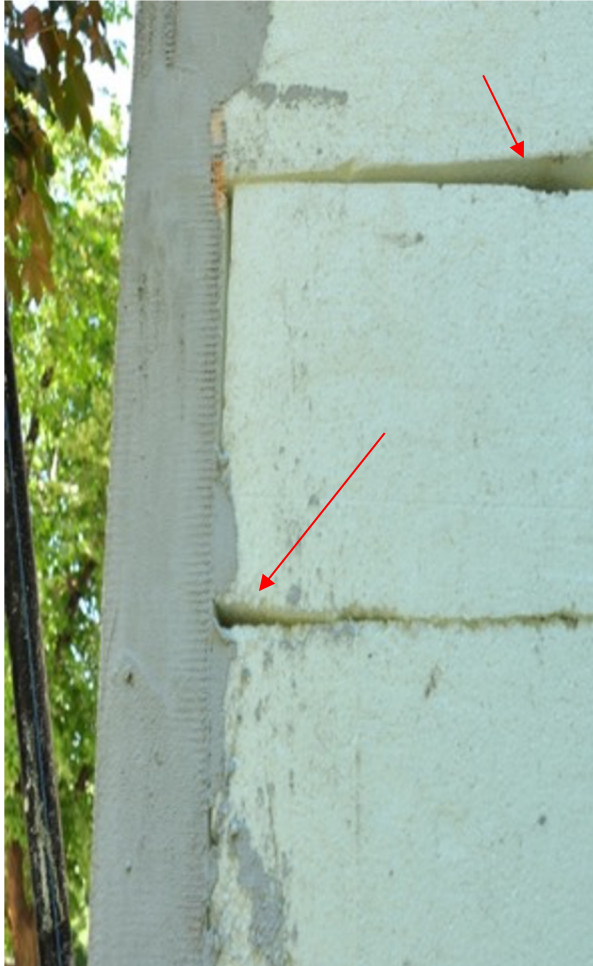
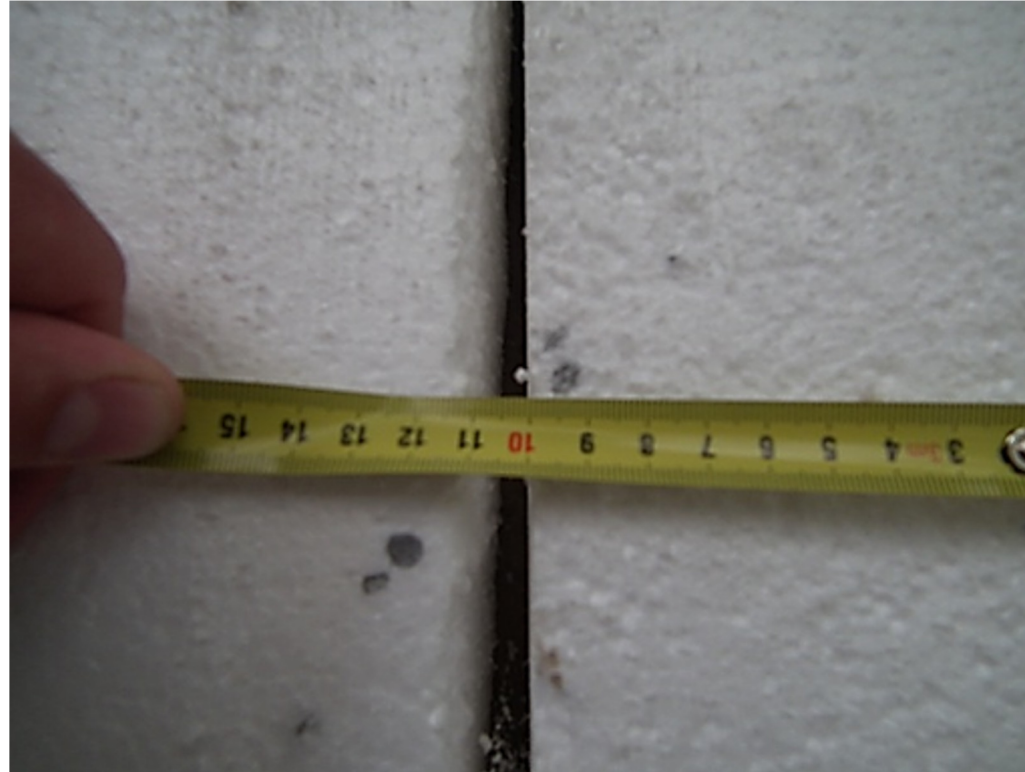
Wrong application of thermal insulation boards

Substantial joint (>1cm) between thermal insulation panels

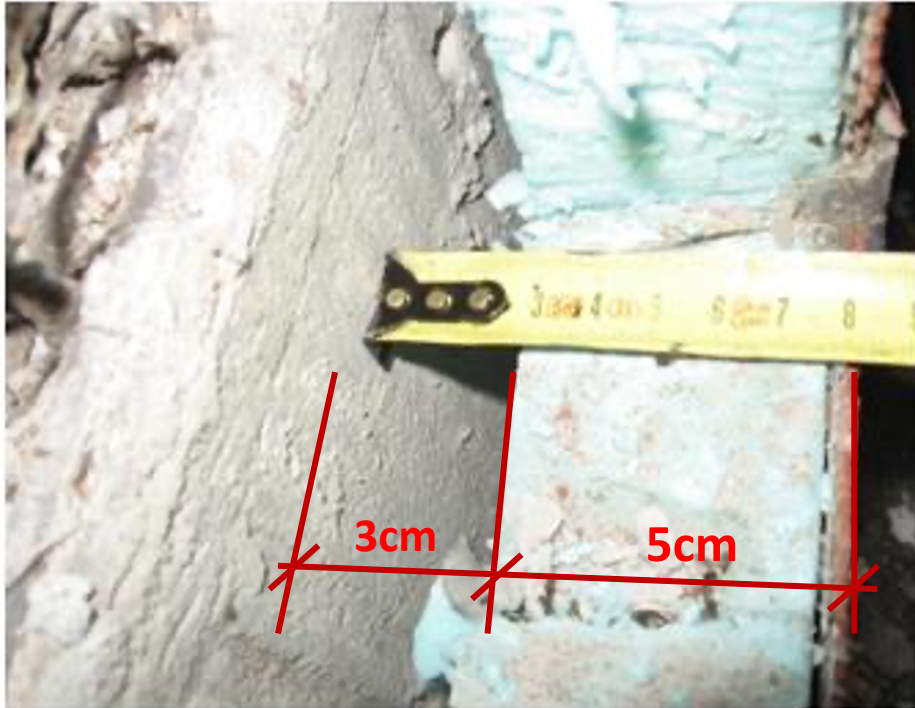
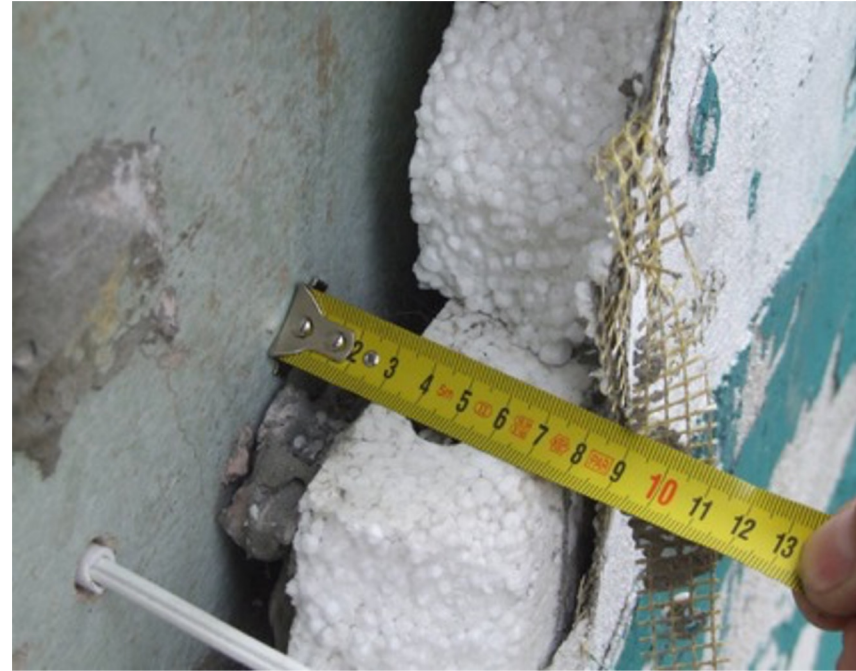
Wrong application of thermal insulation boards

Insulation board not in contact with the substrate and attached with spot adhesive only without bead

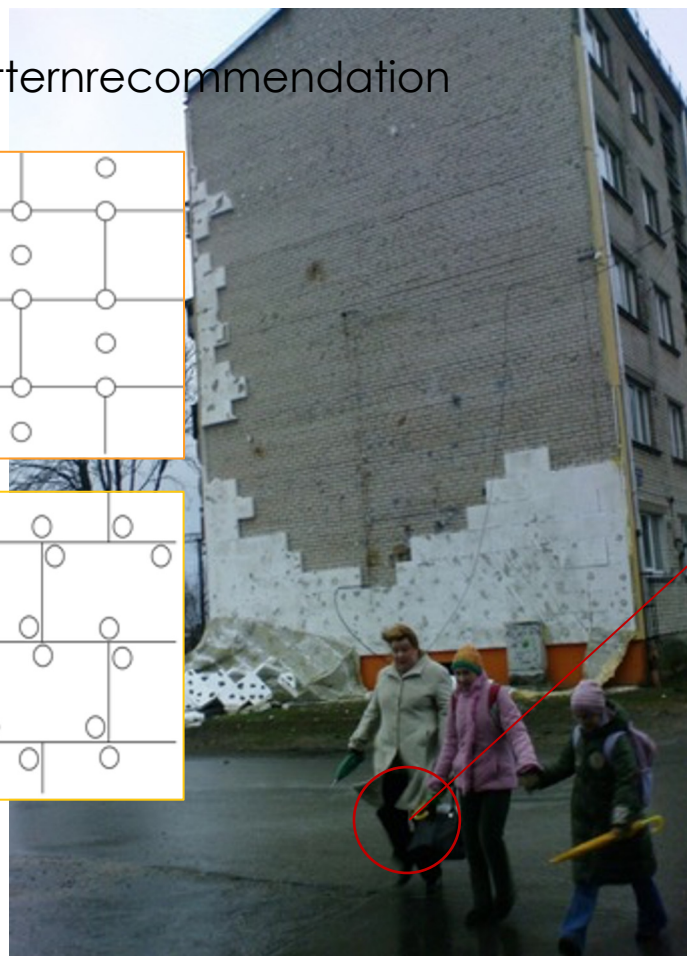
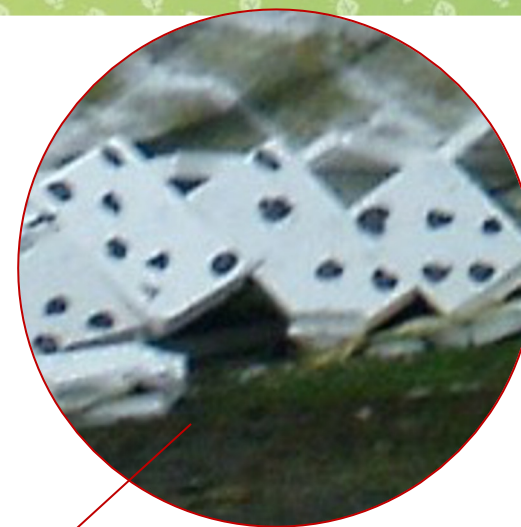
Anchoring the thermal insulation boards

1. Wrong application of the adhesive mortar (lack of bead layer, only few spots applied)
2. Anchors were not installed

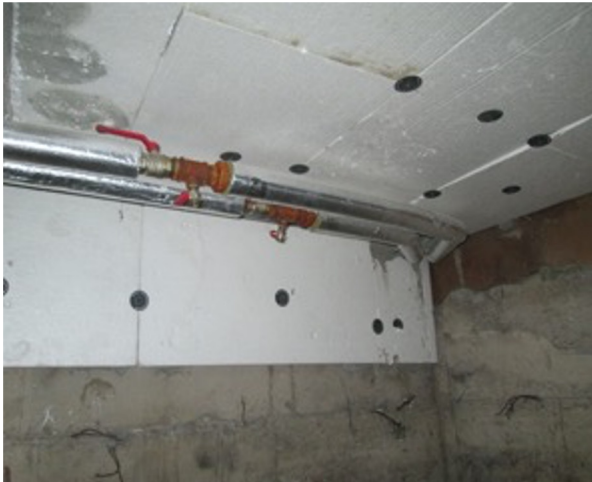
- In most EU countries the use of EPS in basements for cellar slab insulation is not allowed
- Fire braking wool layers are not used if EPS is applied. (very difficult to check after construction works are finished)
- Electrical wires and luminaries are often embedded in the insulation layer

Use of EPS for cellar slab insulation Embedded wires and lighting fixtures
