Training workshop “Studying international practices in implementation of innovative energy efficiency technologies in the electric power industry. Methodology, goal and objectives of electricity and heat consumers energy survey”

The most common mistakes in the construction of passive buildings and technical measures in construction supervision to ensure energy efficiency

Agris Kamenders,
International Consultant, SECCA

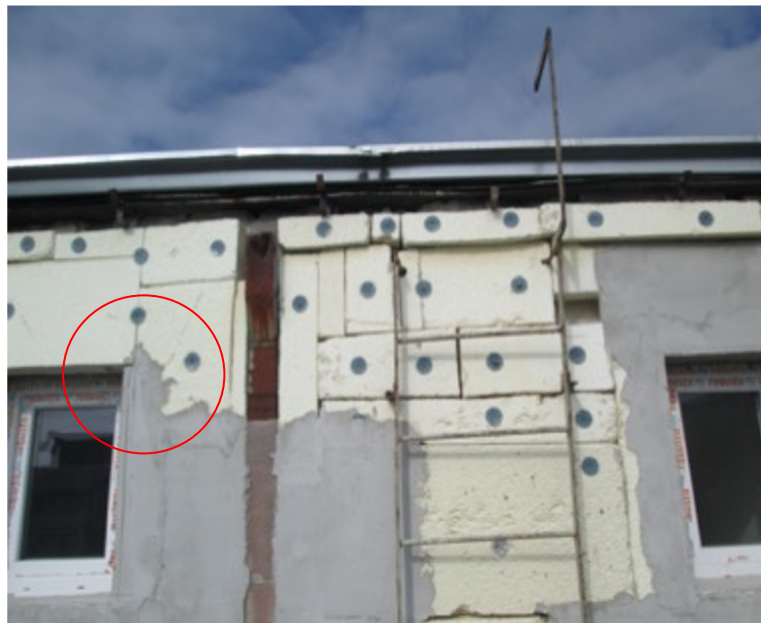
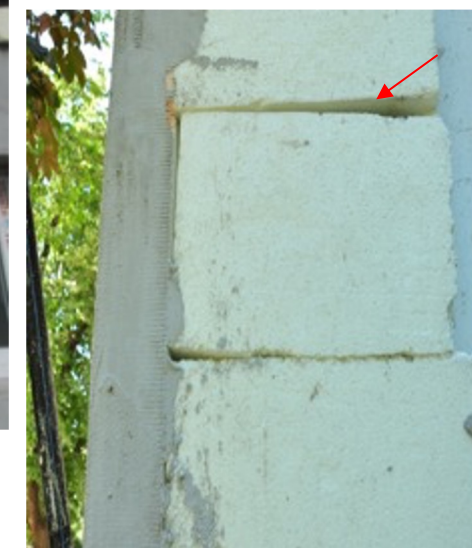
Implementation

Wrong application of thermal insulation boards

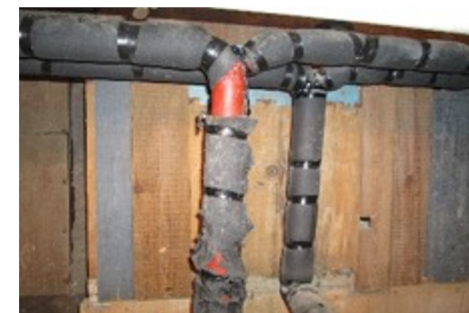
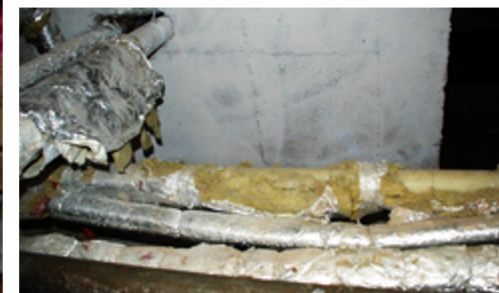
Poor quality of technical insulation

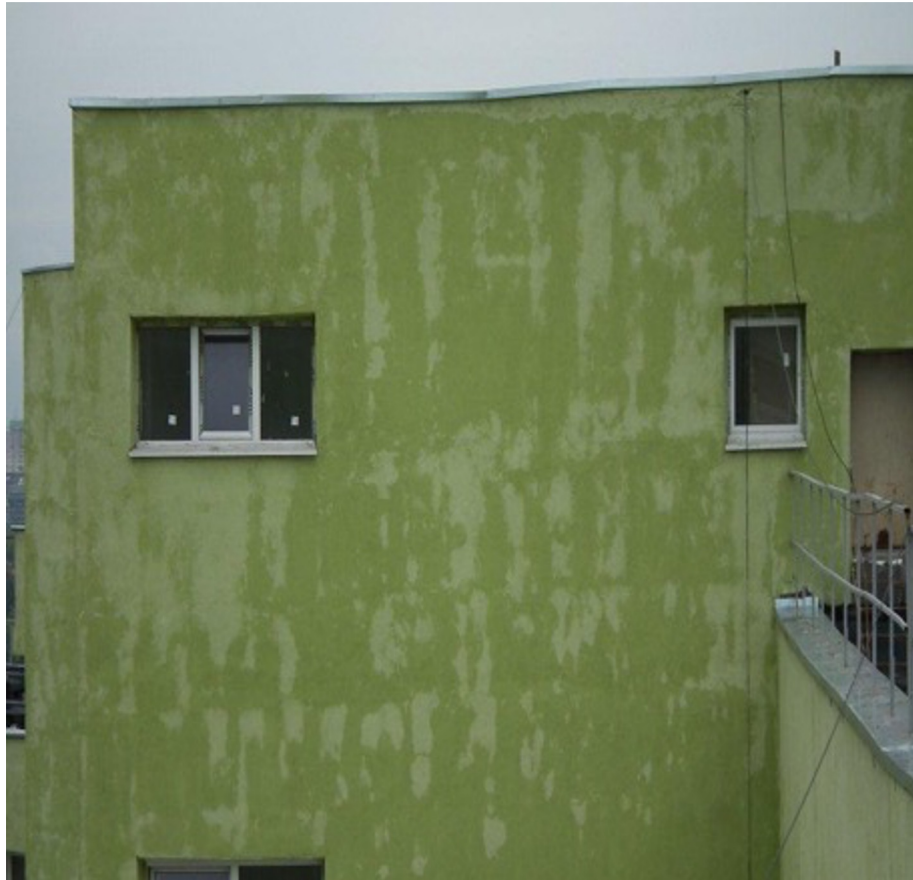
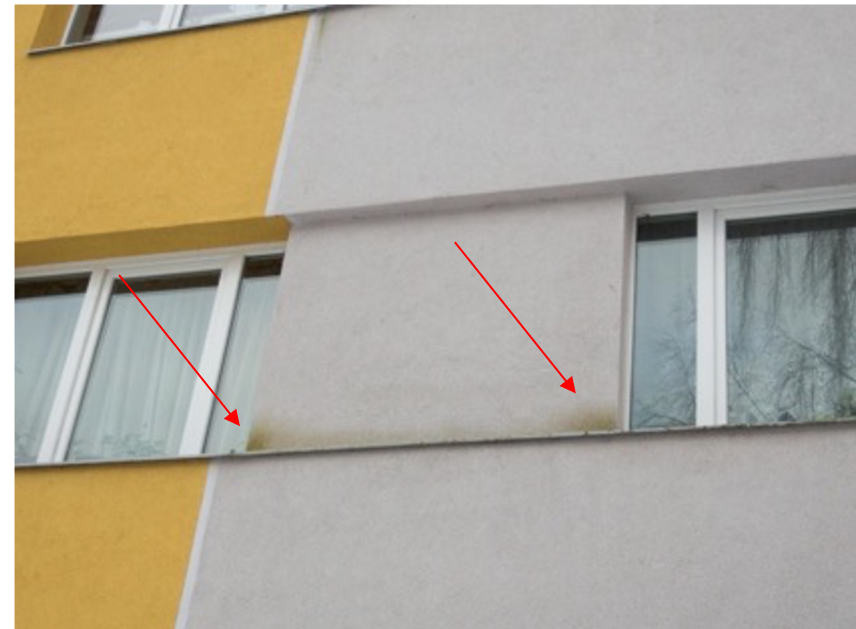
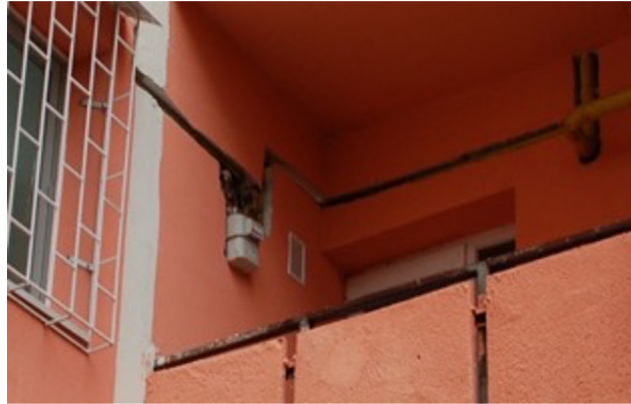
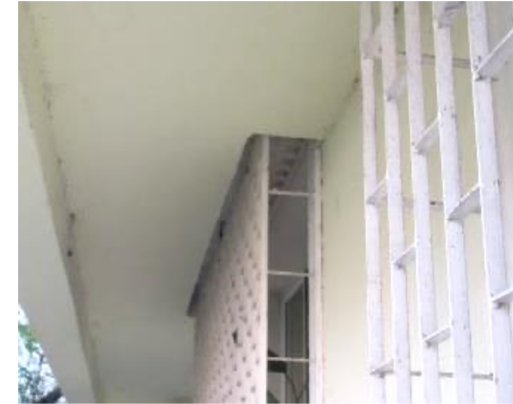
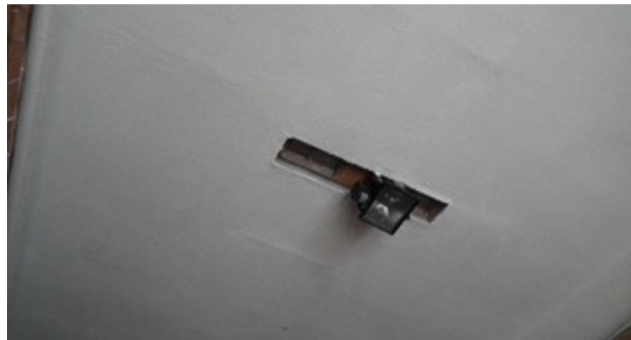
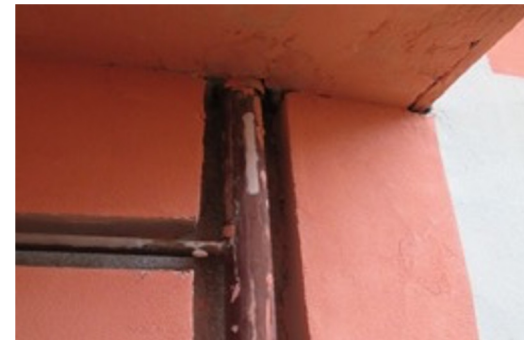
Final finishing

- Gas pipes and meters
- Electric installation
- Lighting installation
- Rain water pipes
- Air cooling units
- Antennas and SAT
- Ventilatioin grids
- Metal grids
- etc.

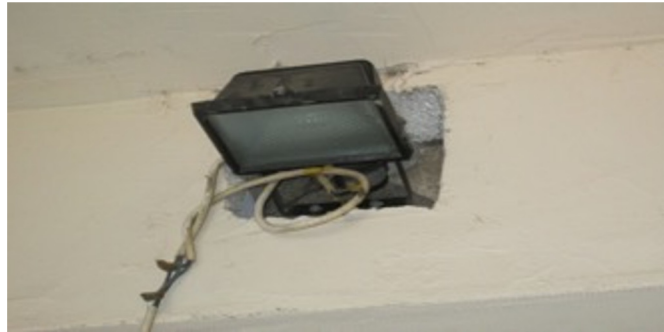
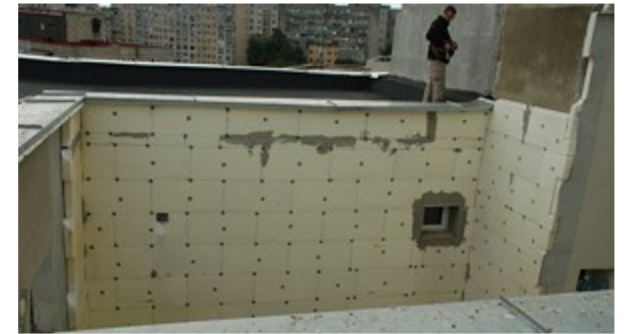
- In most EU countries the use of EPS in basements for cellar slab insulation is not allowed
- Fire braking wool layers are not used if EPS is applied. (very difficult to check after construction works are finished)
- Electrical wires and luminaries are often embedded in the insulation layer

Use of EPS for cellar slab insulation Embedded wires and lighting fixtures

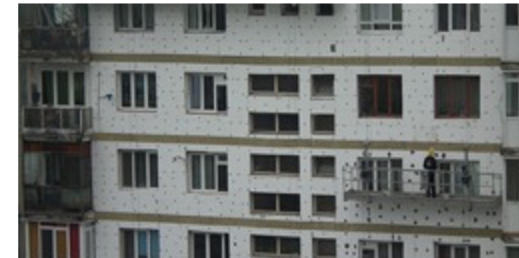
Examples with fire braking mineral wool layers

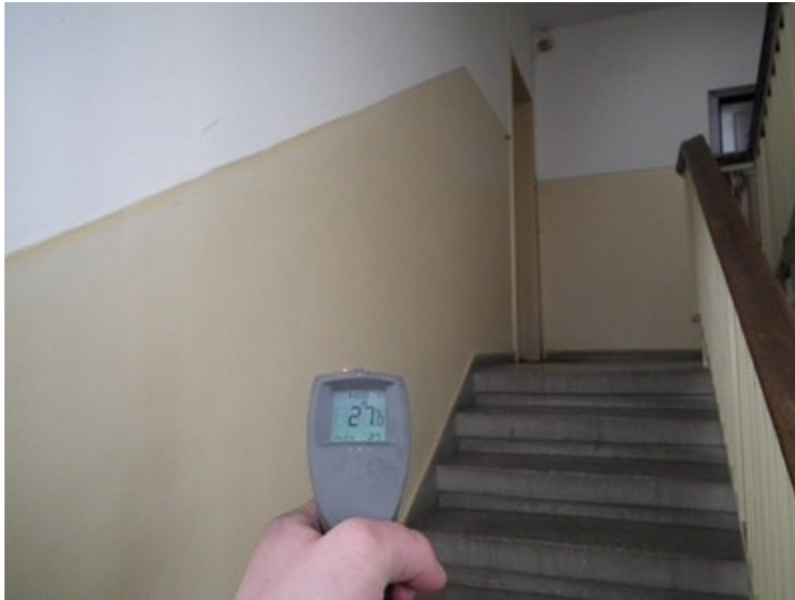
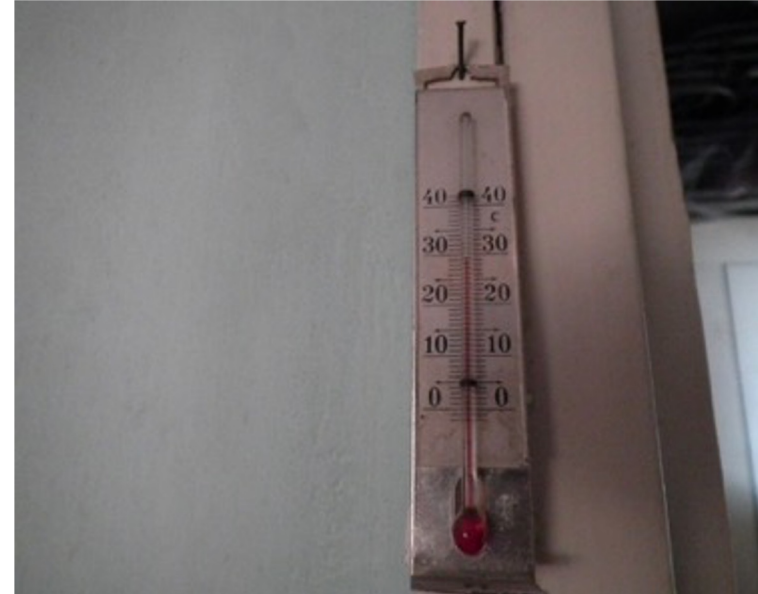
After renovation remember to tune your heating system, otherwise 27°C in the staircases and 30°C in apartments can be expected
